## RAPID ANALYSIS REPORT

# Scientific Anatomy of the 26 August 2026 Bhotekoshi Flash Flood

IRDR Young Scientist's rapid analysis of the flood event

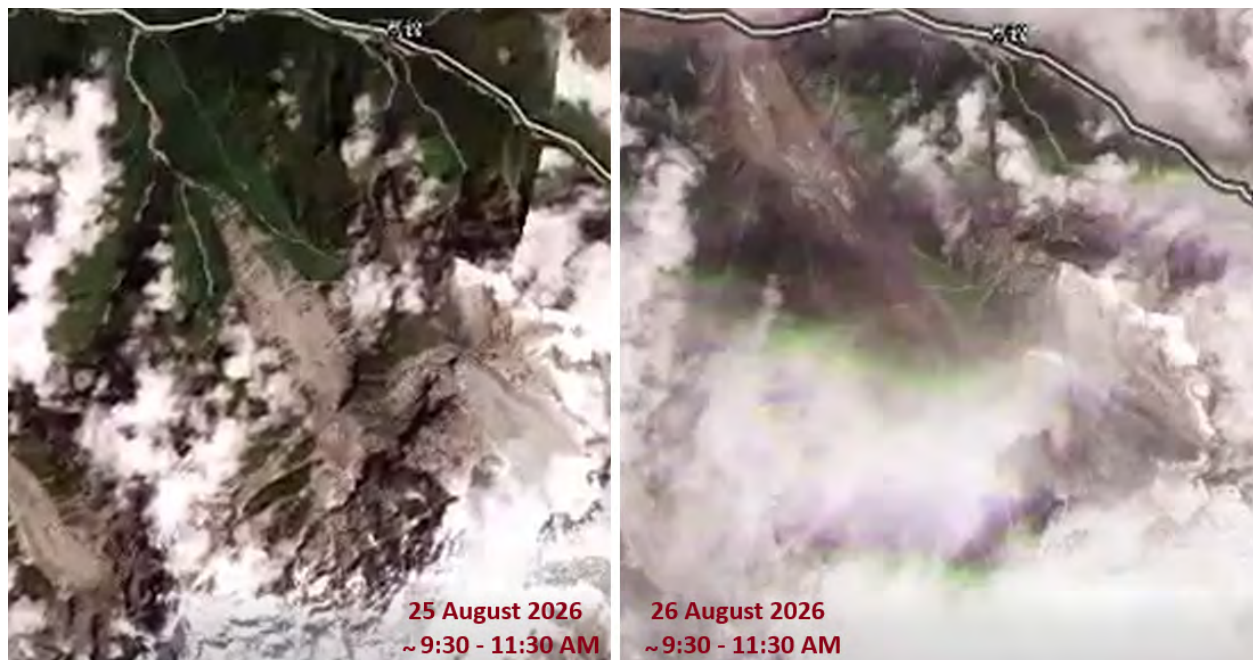
*Image: Satellite image of the ice/rock avalanche location from 25 and 26 August 2026 (Source: Planet).*

Within a few hours, the team examined satellite observations, weather information, rainfall records, and river-discharge data to identify the likely source and mechanism of the event. The initial analysis identified a suspected slope-failure area around Deding in the north face of the Langtang-Lirung region.

Pre-event satellite observations also revealed changes in snow and ice conditions around the suspected source area, including snow retreat and changes in snow accumulation. Subsequent pre-event and post-event satellite imagery showed that the suspected location closely corresponded with the observed source area, strengthening the initial interpretation.

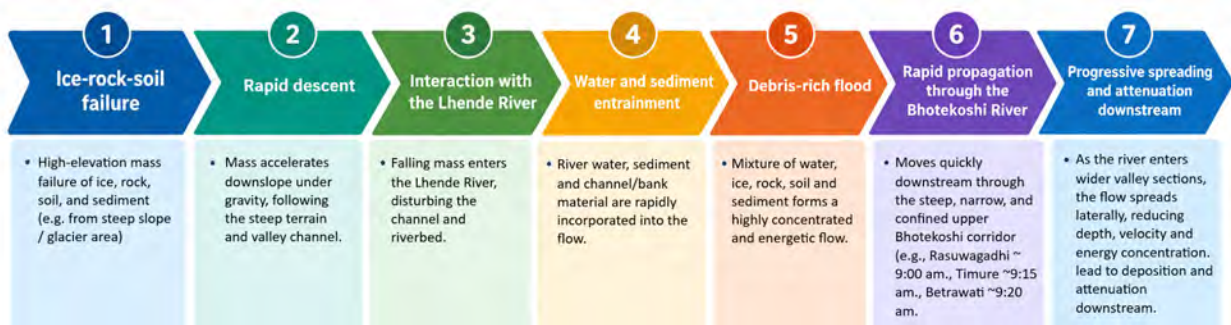
The downstream propagation can therefore be understood as part of a cascading process initiated by the high-elevation ice-rock-soil failure:

The observed arrival times and changing flood behaviour along the river indicate that the magnitude and destructive capacity of the event were controlled not only by the initial volume of water, but also by the mass of ice, rock, soil, and sediment introduced into the river and subsequently entrained during downstream propagation.

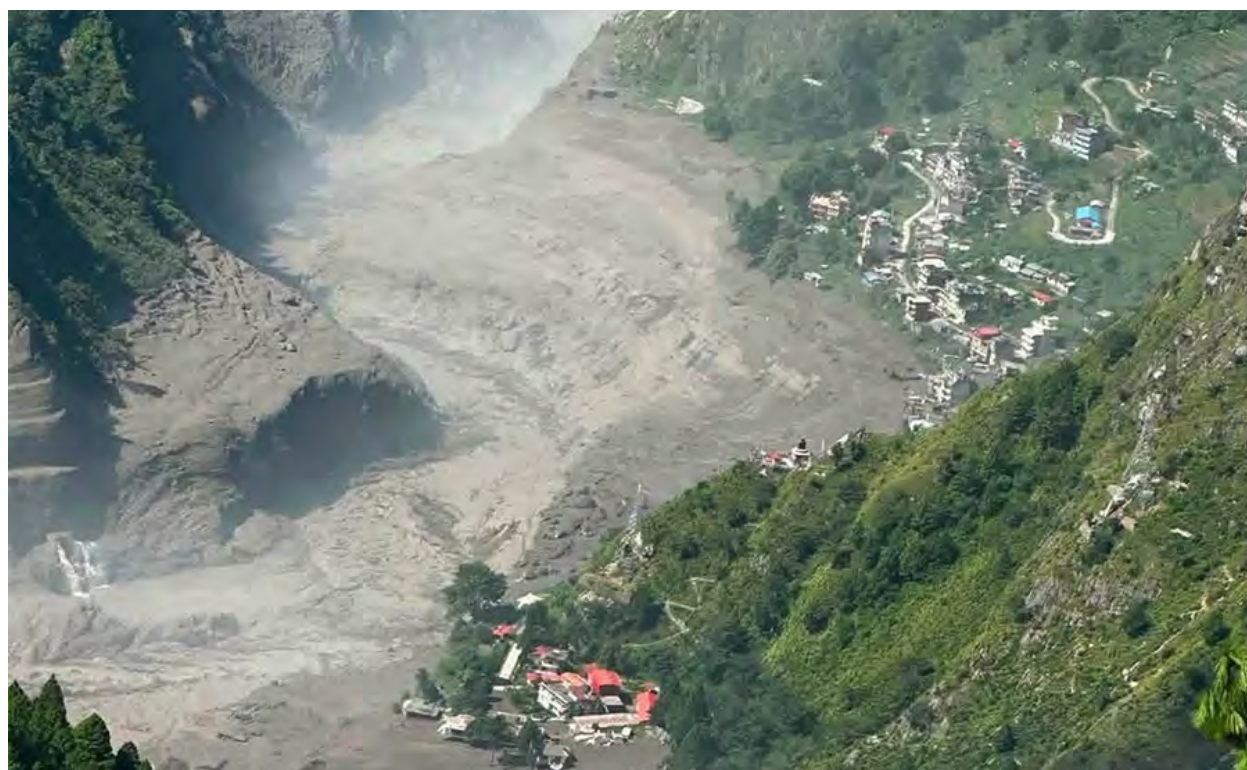
**Photo source:** <https://www.onlinekhabar.com/2026/08/2003997/floods-damage-431-megawatt-power-plant>

The disaster also produced major cascading impacts on the energy and critical infrastructure sectors. Preliminary Nepal Electricity Authority information indicated that 748 MW of hydropower capacity was affected, comprising 354 MW from operational projects and 394 MW from projects under construction. Several hydropower facilities, including Rasuwagadhi, Chilime and Trishuli-3A, were reported damaged, along with associated transmission and distribution infrastructure. The 220 kV Trishuli 3B Hub Substation was completely destroyed, while multiple transmission lines were disrupted. These losses affected electricity generation, transmission
